Subject: September 10, 2014 Compliance Evaluation Inspection

CWA COMPLIANCE EVALUATION INSPECTION REPORT
U.S. ENVIRONMENTAL PROTECTION AGENCY, REGION 5

Northwest Illini Feedlots
12490 Illinois Route 73
Lanark, Illinois 61046
Carroll County
42.116N, 88.835W

ILA010093 (Expires September 30, 2014)

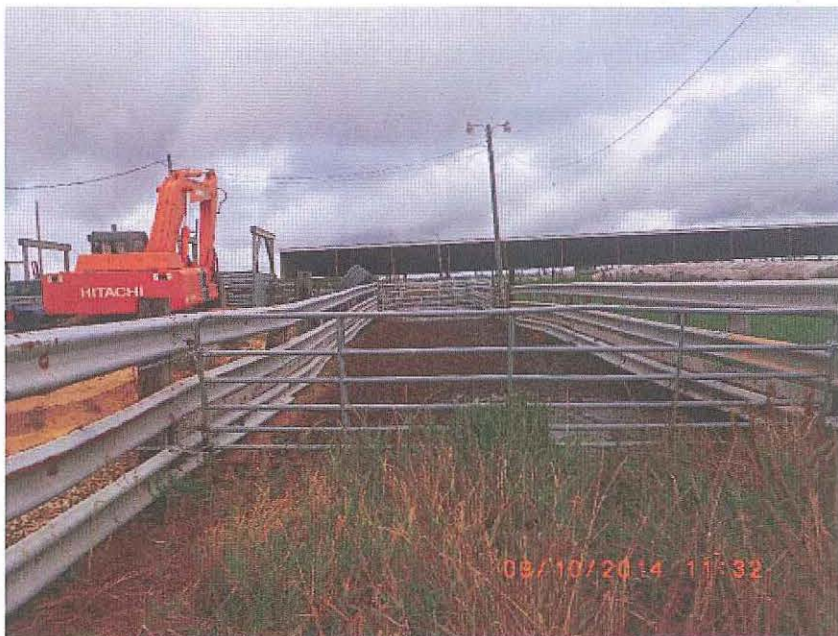
1: IMGP1363

EPA began the walkthrough on the south side of the Sort Alley. Surface flow off the Sort Alley would flow to the south and to a pipe at ground level. The pipe would transport any manure or process wastewater to the Lagoon directly to the south.

Description: Sort Alley is slanted so surface runoff would flow to the south.

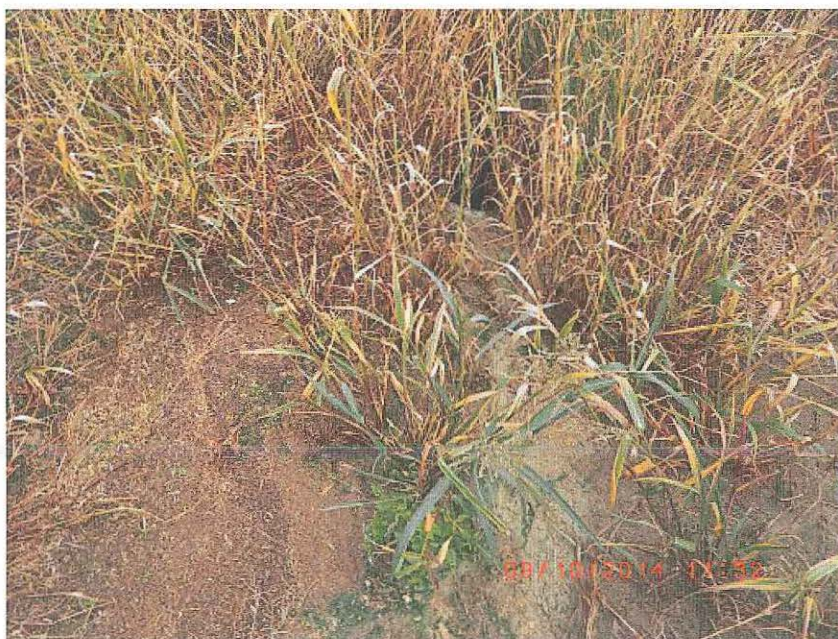
2: IMGP1364

Description: Flow off the Sort Alley goes into this inlet south of the alley.

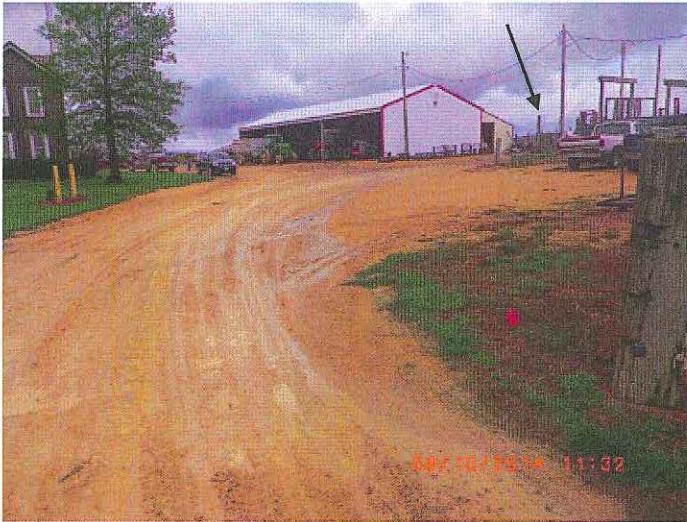
3: IMGP1365

Manure and process wastewater also could run off from the west side of the Sort Alley. It would then flow south down the facility driveway and to the Lagoon.

Description: Process wastewater from the west side of the Sort Alley (black arrow) would flow along the driveway to the south and east and then flow to the Lagoon.

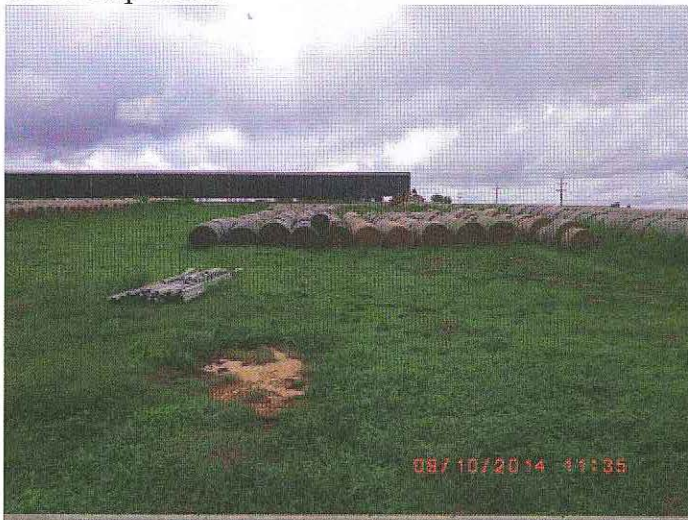
4: IMGP1366

South of Barn B, former dirt feedlots have been abandoned as animal confinement areas and now are where round bales are stored. The area was completely vegetated on the day of the inspection.

Description: Round bales are stored in the yard south of Barn B.

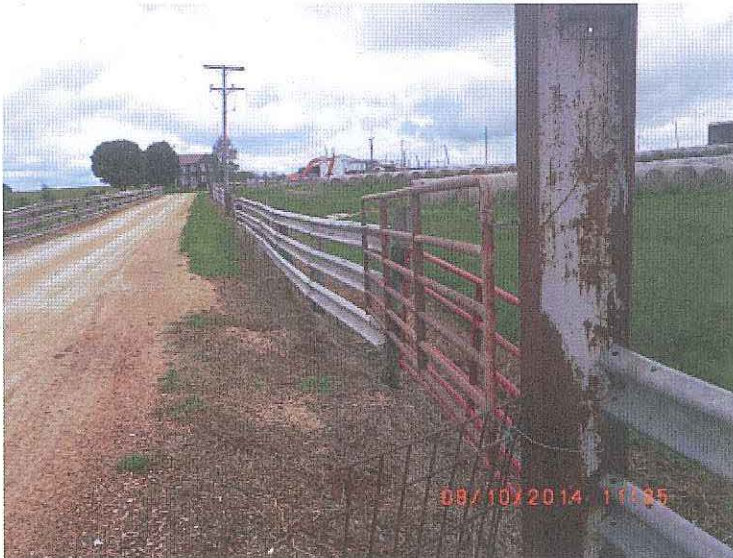
5: IMGP1367

Description: Looking back along the southern edge of the yard where the round bales are stored.

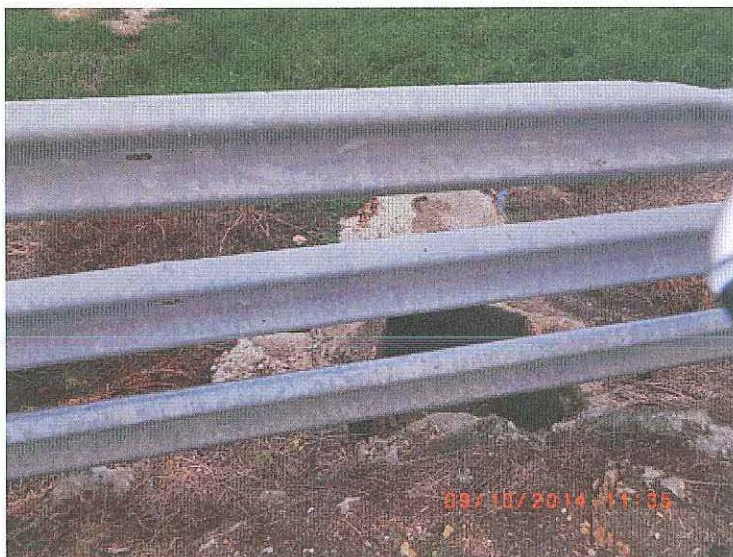
6: IMGP1368

A storm water inlet at the southeast corner of the former feedlots transports flow to under the facility driveway and to the yard to the south. The flow of storm water would flow to the south and to Straddle Creek.

Description: Storm water inlet in the southeast corner of the yard.

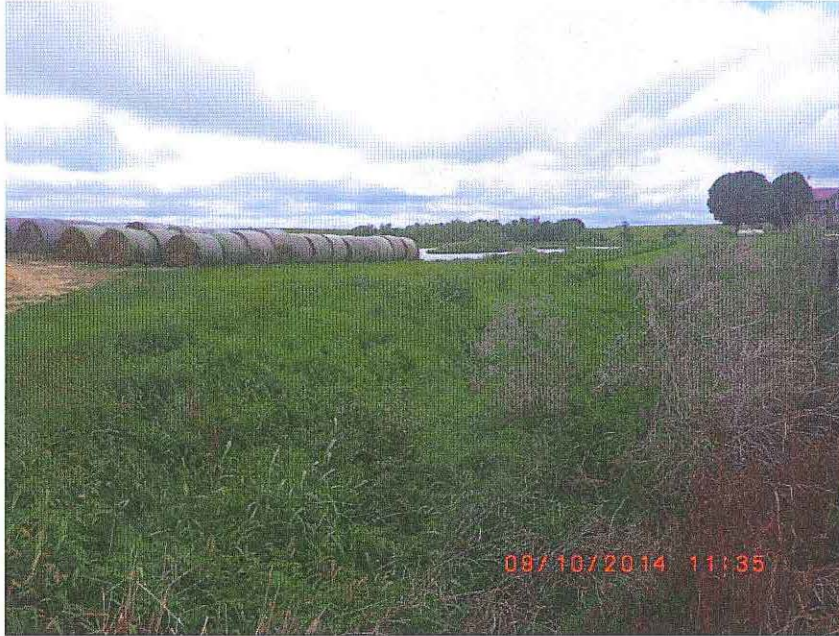
7: IMGP1369

Description: Storm water outlets in grassed area south of the facility driveway and flows to Straddle Creek.

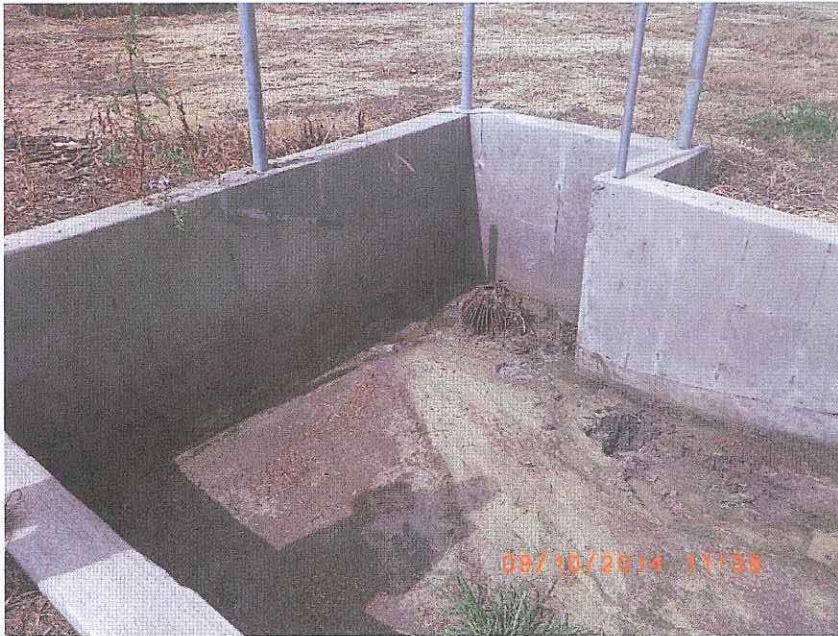
8: IMGP1370

Corn silage is stored in concrete bunkers south of the facility driveway. Additional commodities are stored in a Commodities Barn in the Feed Storage Area. Process wastewater from the Feed Storage Area flows to the north and to a concrete Catch Basin. A dirt berm on the ground directs the flow to the Catch Basin. A pipe at the bottom of the basin transports the process wastewater to the Lagoon.

Description: Catch Basin for silage leachate is located at the northwest corner of the Feed Storage Area.

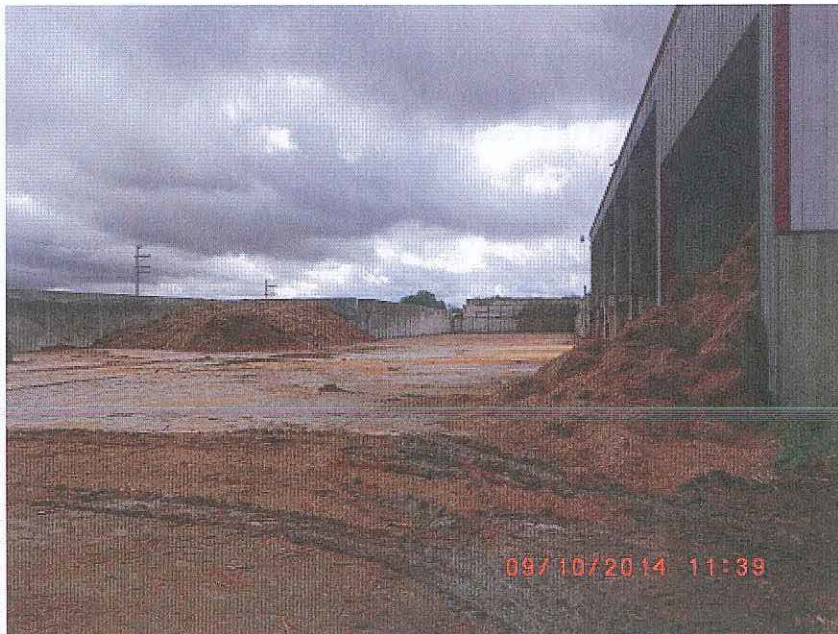
9: IMGP1371

Description: Silage leachate flows over the ground to the Catch Basin.

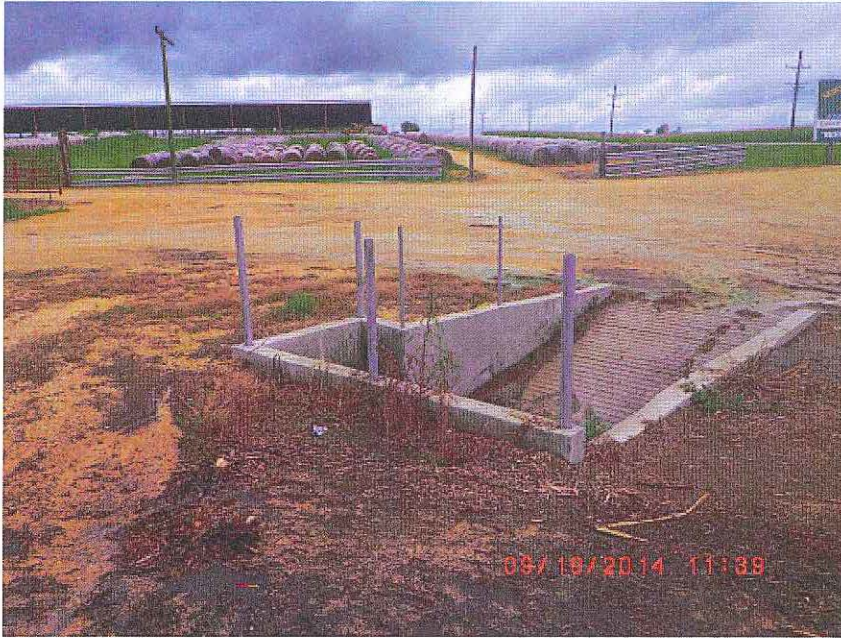
10: IMGP1372

Description: Silage leachate flows over the ground to the Catch Basin.

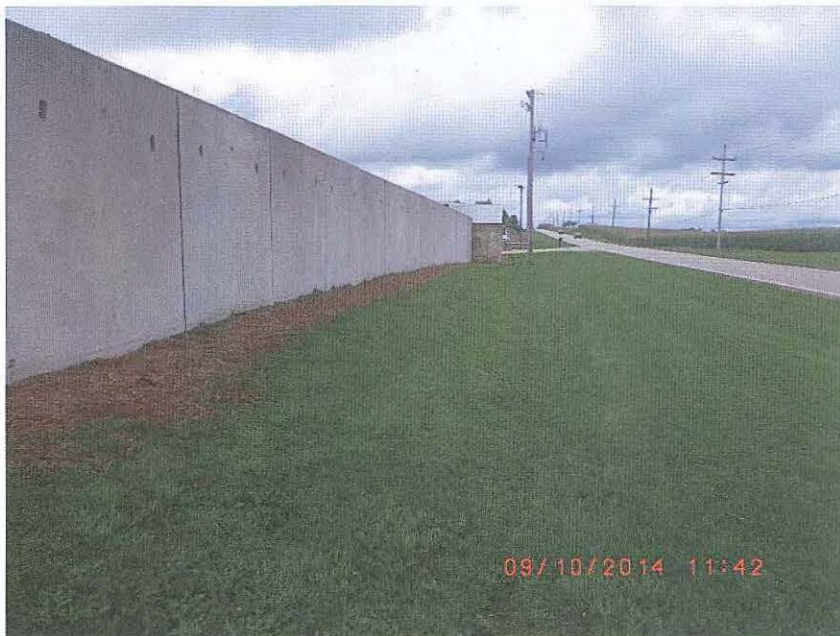
11: IMGP1373

Description: Concrete feed bunker wall facing IL Route 73.

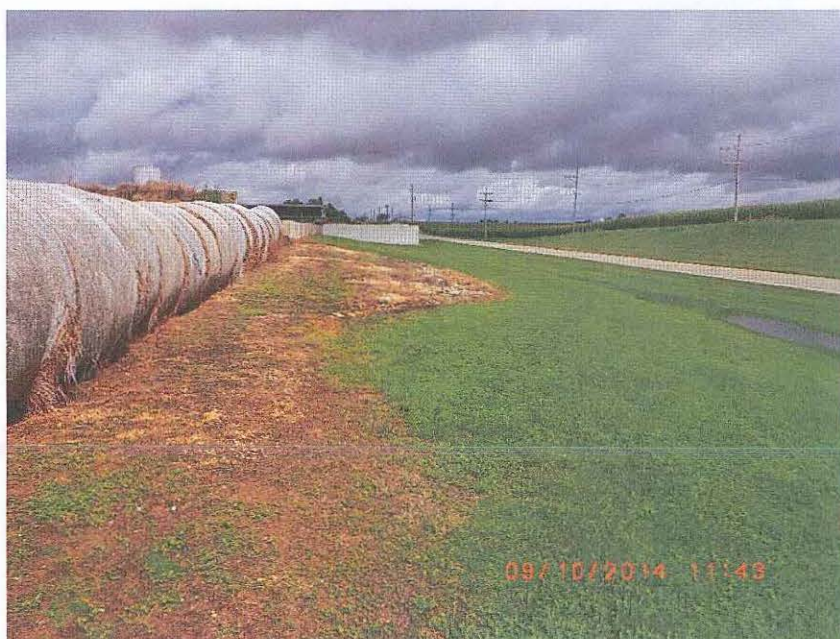
12: IMGP1374

Description: South of the concrete bunkers, round bales are stored.

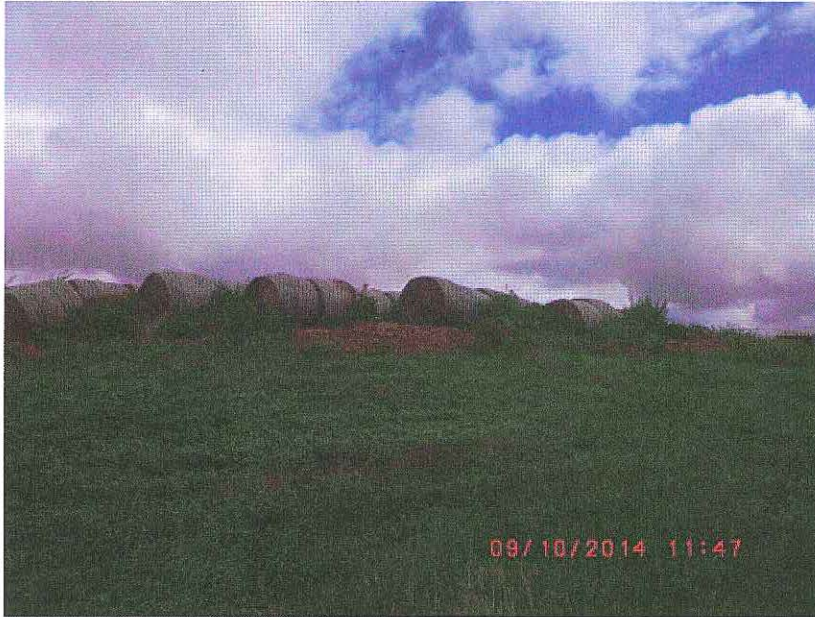
13: IMGP1375

Description: Round bales stored south of the concrete bunkers of the Feed Storage Area.

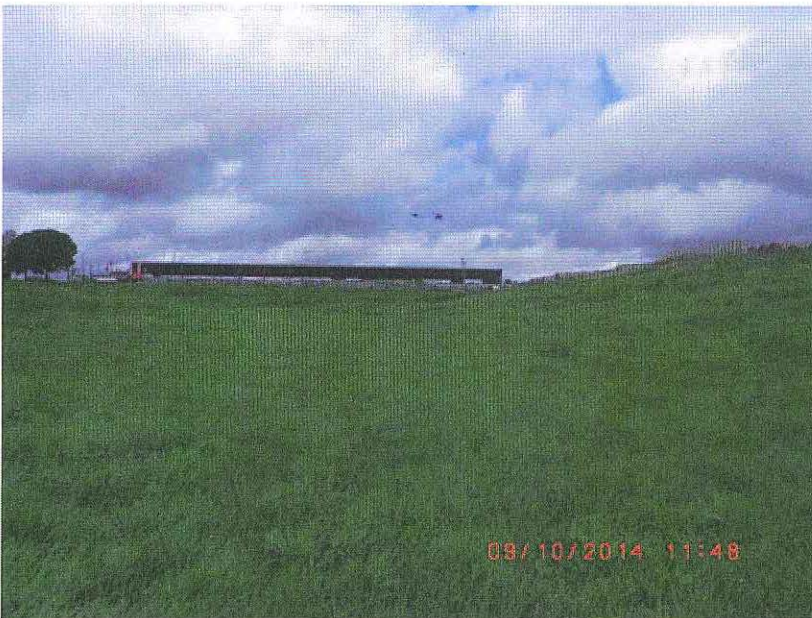
14: IMGP1376

Description: The facility owners have created a secondary ditch to collect any runoff from the round bale area so it won't access the roadside ditch.

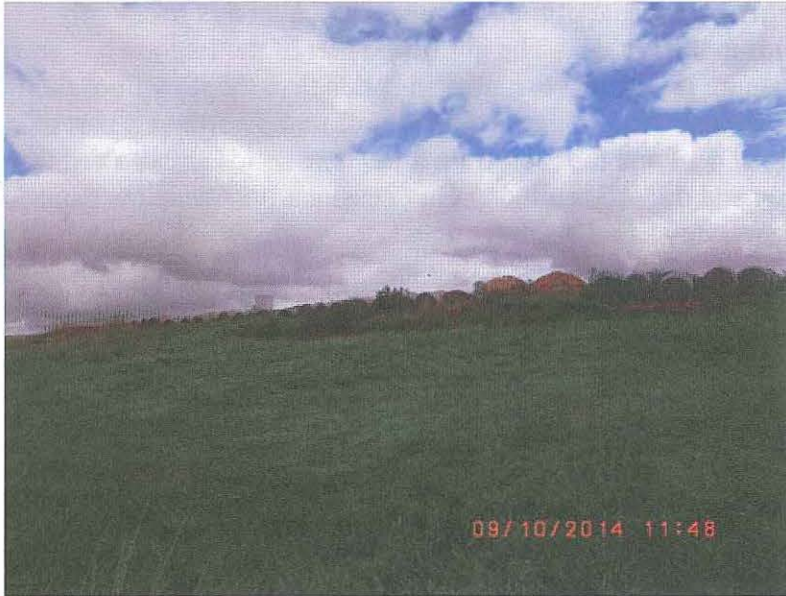
15: IMGP1377

Description: Round bale storage south of concrete feed bunkers.

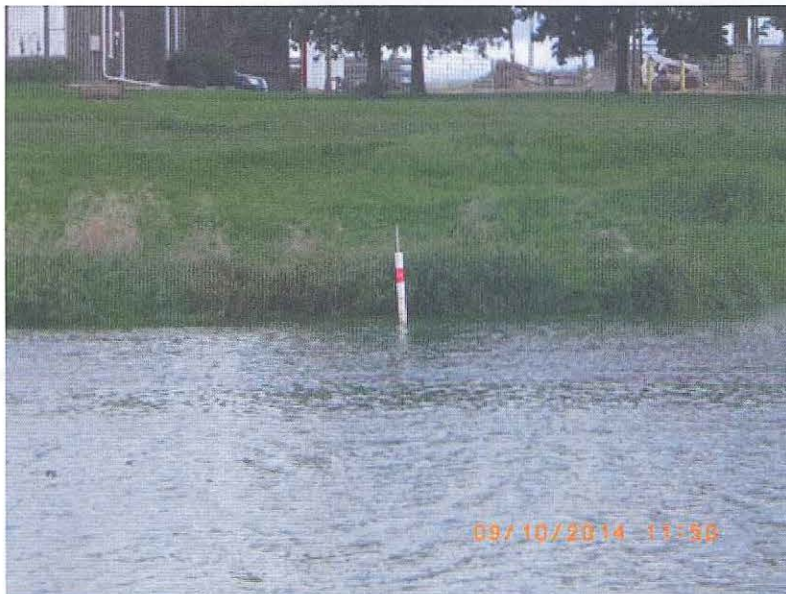
16: IMGP1378

EPA walked to the west to the south side of the Lagoon. EPA observed the depth marker in the Lagoon and noted that there was approximately four feet of freeboard.

Description: Capacity depth marker in the Lagoon.

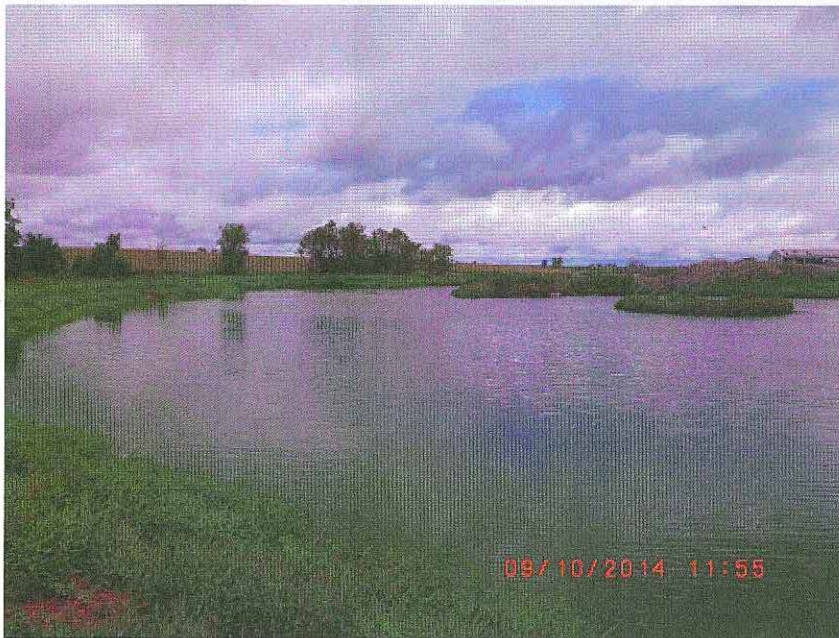
17: IMGP1379

Description: Lagoon has over four feet of freeboard in it.

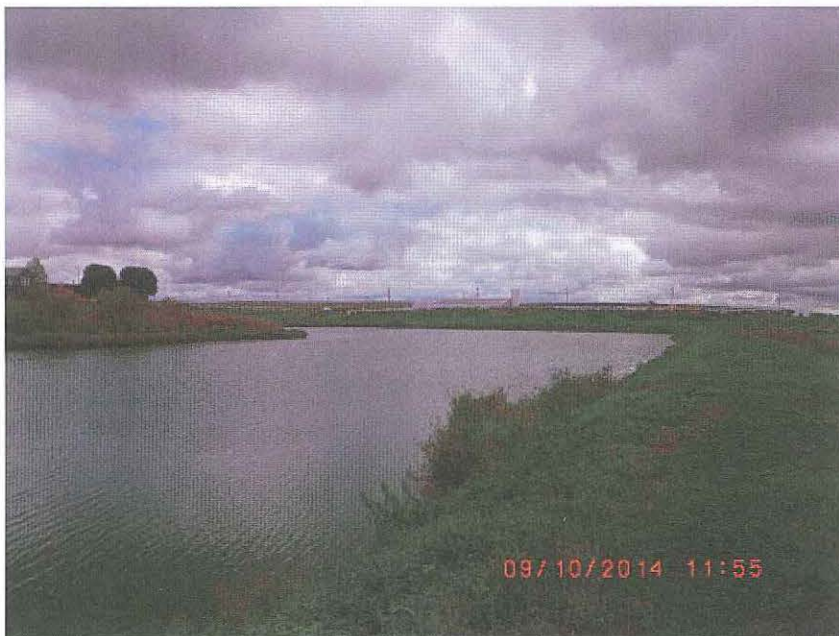
18: IMGP1380

Description: Lagoon has over four feet of freeboard in it.

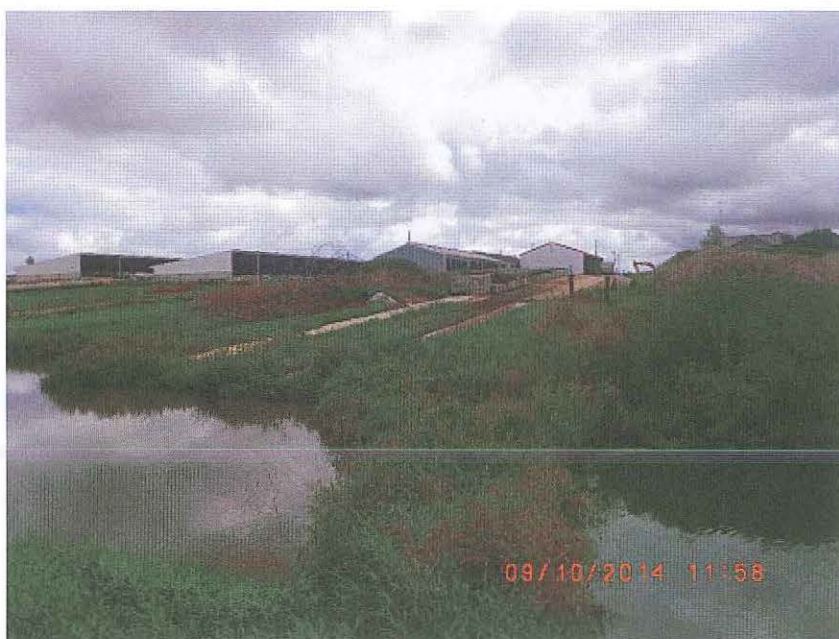
19: IMGP1381

Description: Berm across the northwest part of the Lagoon allows solids to settle in the smaller part of the Lagoon.

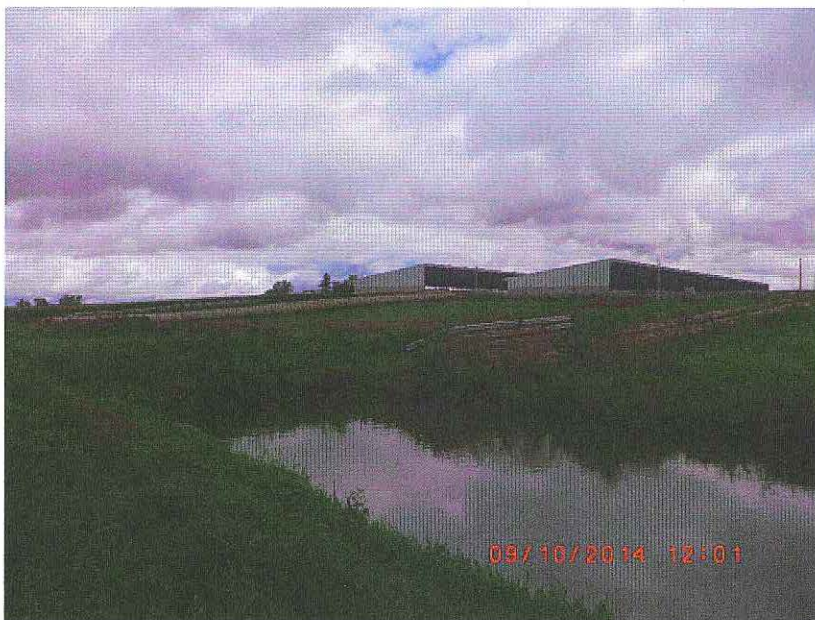
20: IMGP1382

Description: Process wastewater from the Sick Barn and Pens 4, 5, and 6 flow to the west directly to the bermed off part of the Lagoon.

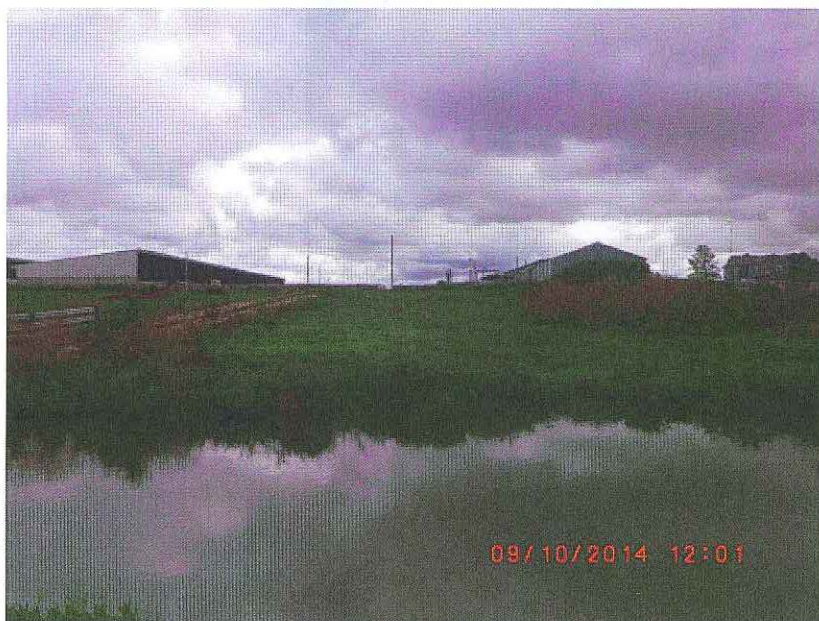
21: IMGP1383

Description: Process wastewater from the Sick Barn and Pens 4, 5, and 6 flow to the west, down the grassed hill, to the bermed off part of the Lagoon.

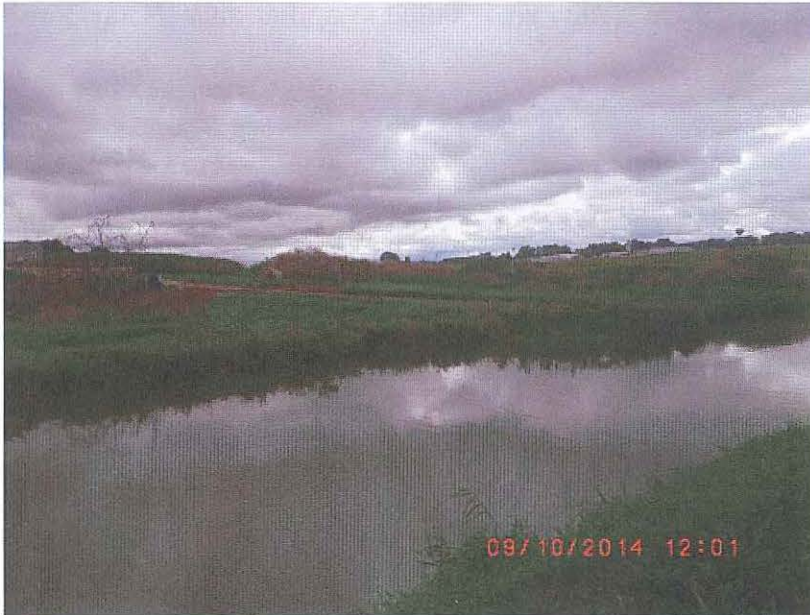
22: IMGP1384

Description: The bermed off part of the Lagoon allows solids to settle out before overflowing into the main part of the Lagoon.

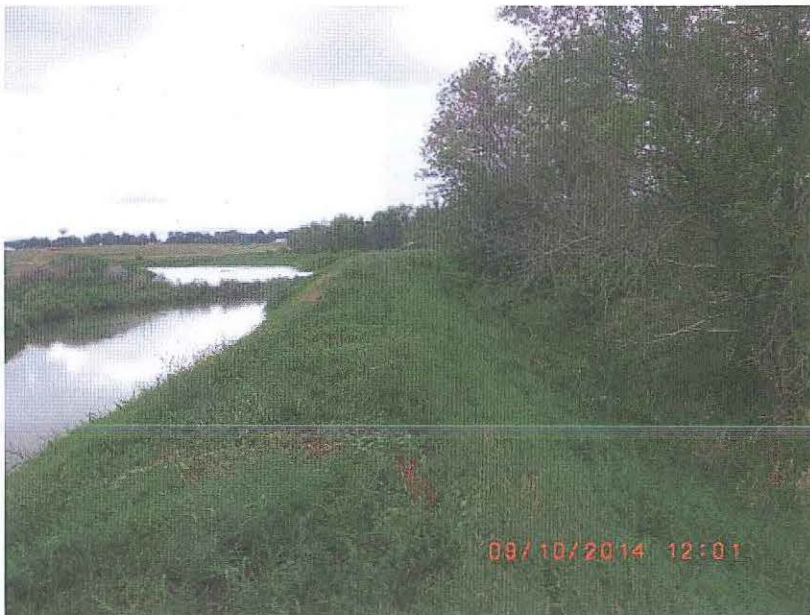
23: IMGP1385

On the day of the inspection the berms were well mowed and there was no woody vegetation growing in them.

Description: Lagoon berms are well maintained with no woody growth and the vegetation is kept mowed.

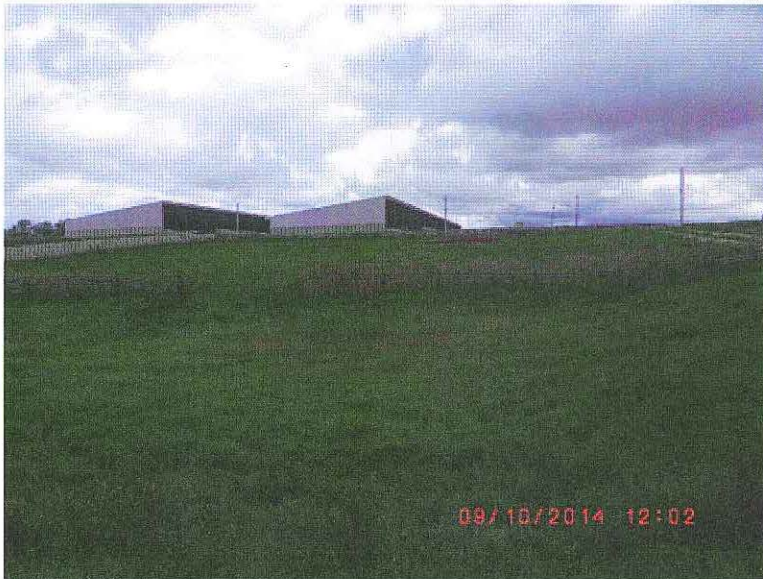
24: IMGP1386

Earthen feedlots on the west side of the facility are not used to confine animals anymore. They have been vegetated.

Description: The lots to the west of the barns are not used to confine animals anymore.

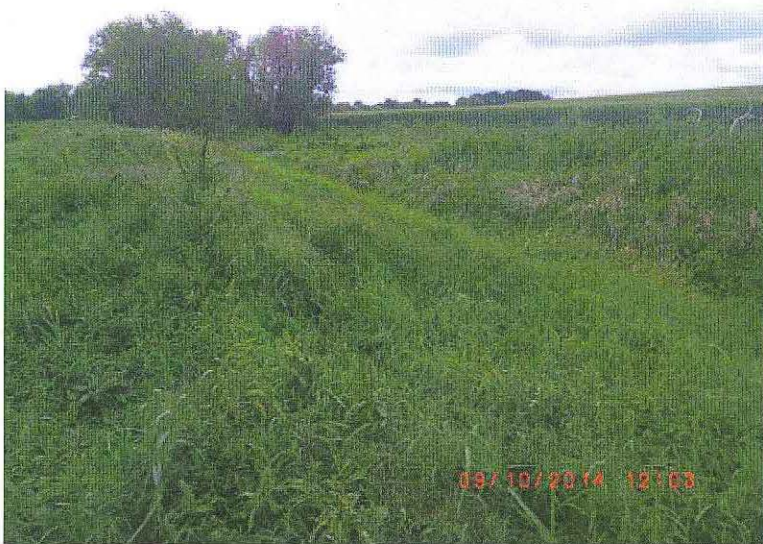
25: IMGP1387

Description: Intermittent unnamed tributary of Straddle Creek is on the west side of the facility.

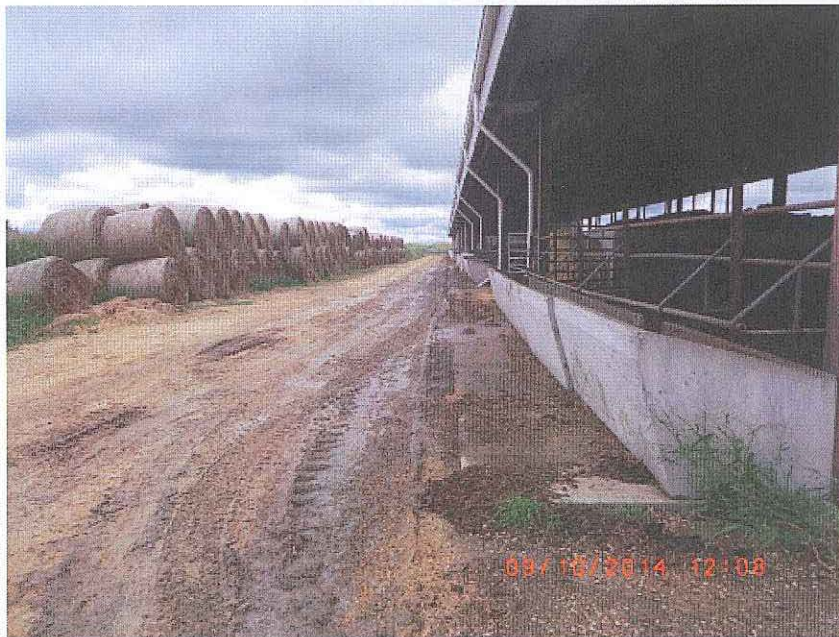
26: IMG1388

Description: Round bales are stored on the north side of Barn A. Note the downspouts from the gutters on the barn. Roof water is directed to the downspouts which are tied to an underground pipe which outlets the storm water to the intermittent unnamed tributary.

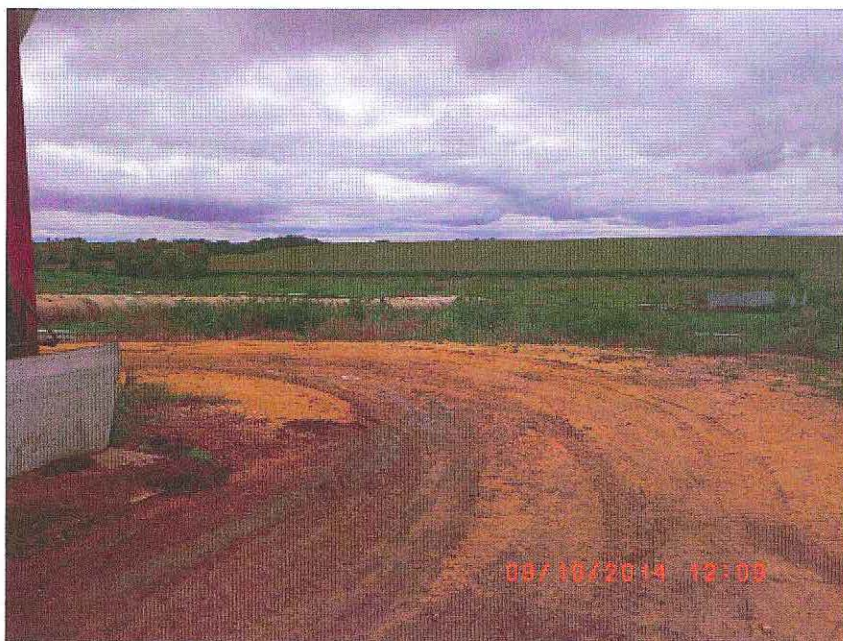
27: IMGP1389

Description: Downspouts from gutters outlet near the intermittent unnamed tributary near the northwest corner of the dirt lot to the west of Barn A.

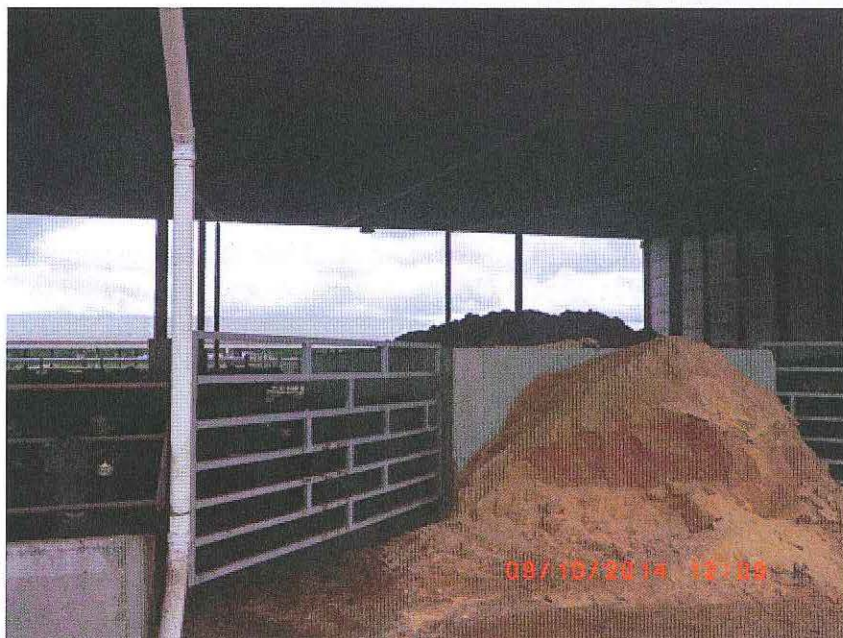
28: IMGP1390

Description: New sand pile under the barn roof.

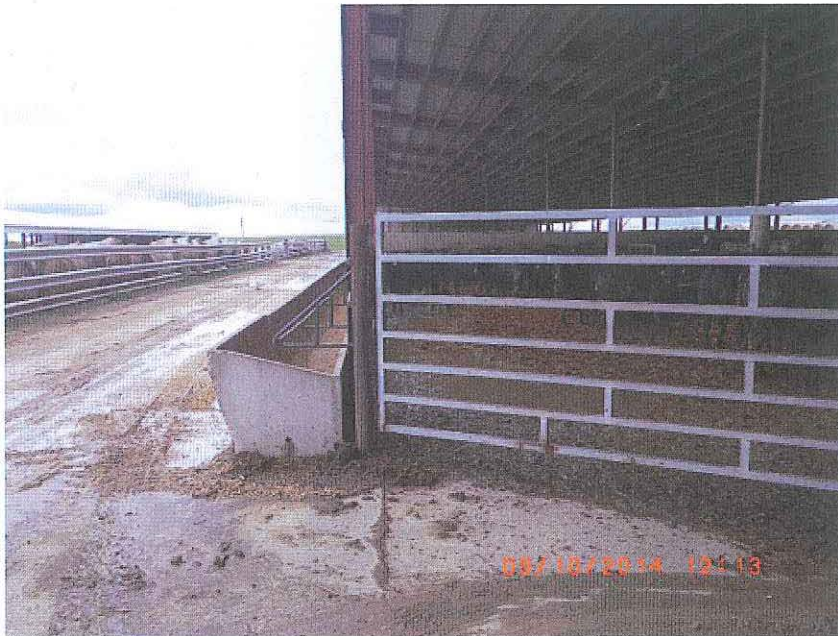
29: IMGP1391

Description: Bed pack in the middle of the barn. The barn edges are scraped daily.

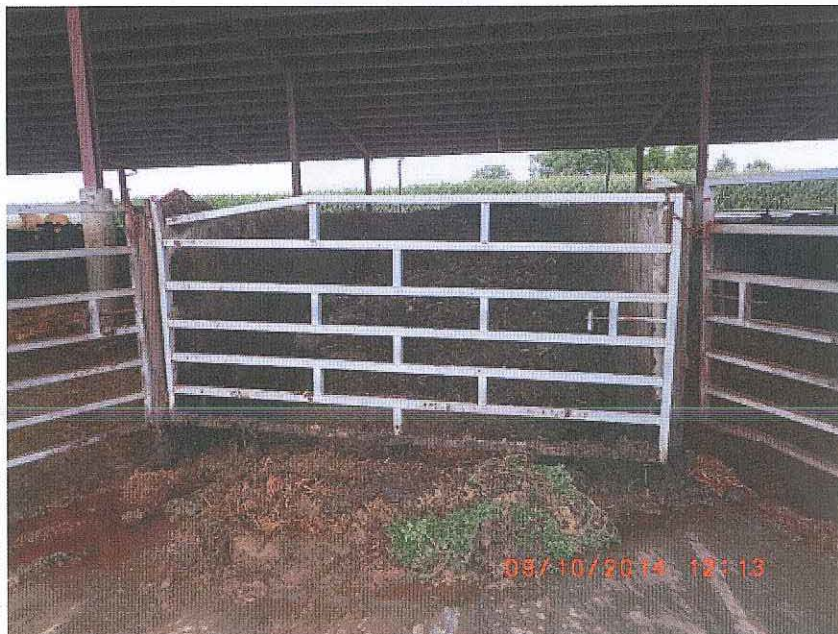
30: IMGP1392

Description: Scraped manure and bed pack is stacked in concrete bunkers inside the barn.

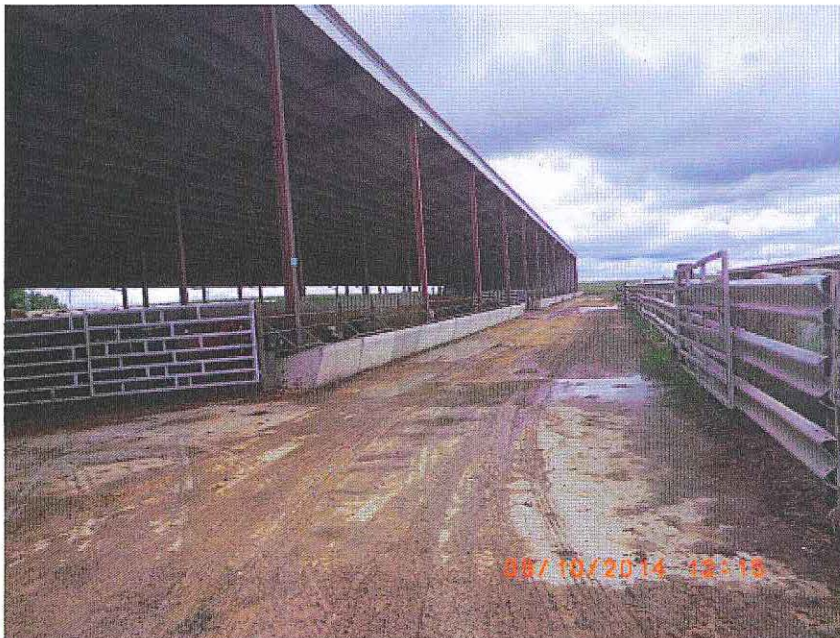
31: IMGP1393

Description: Driveway on south side of Barn A.

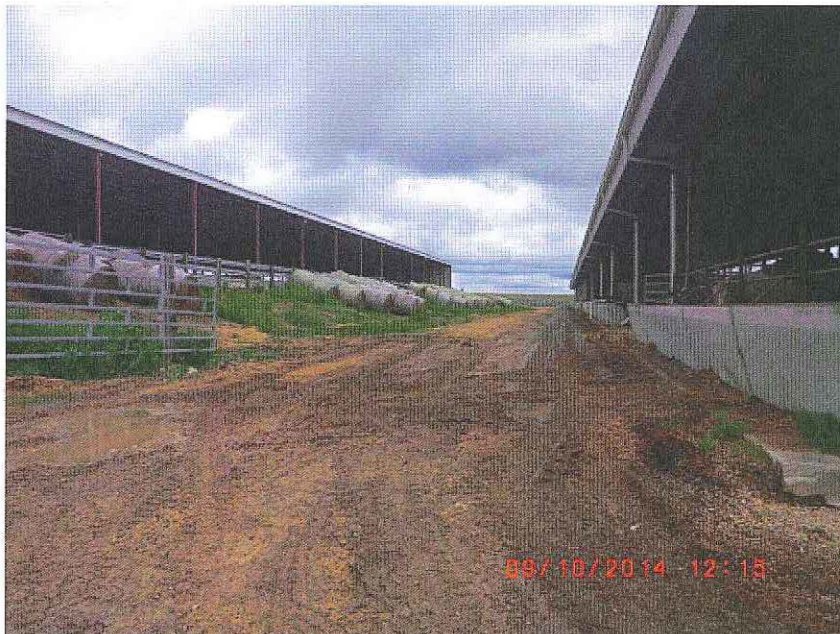
32: IMGP1394

Description: Driveway on north side of Barn B.

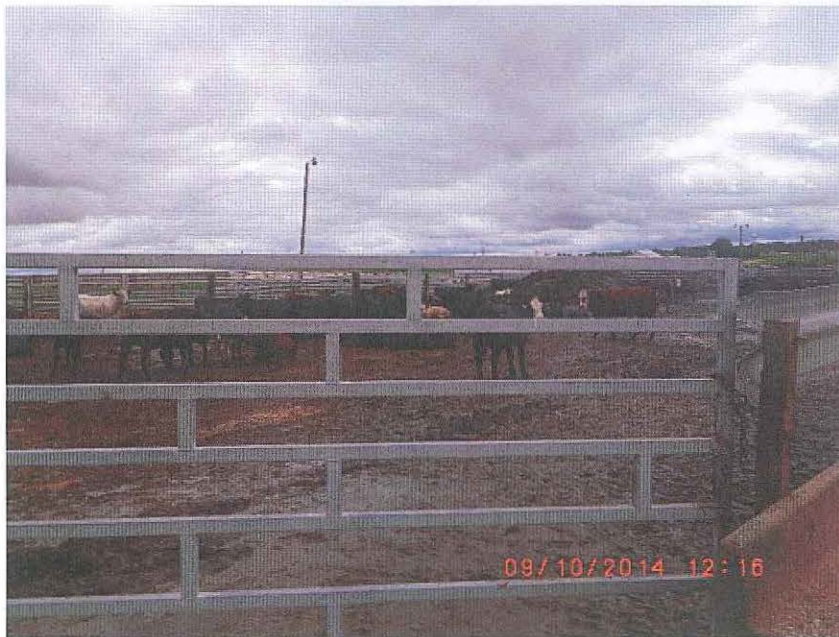
33: IMGP1395

Description: Cattle in the Receiving Pens 14 and 16.

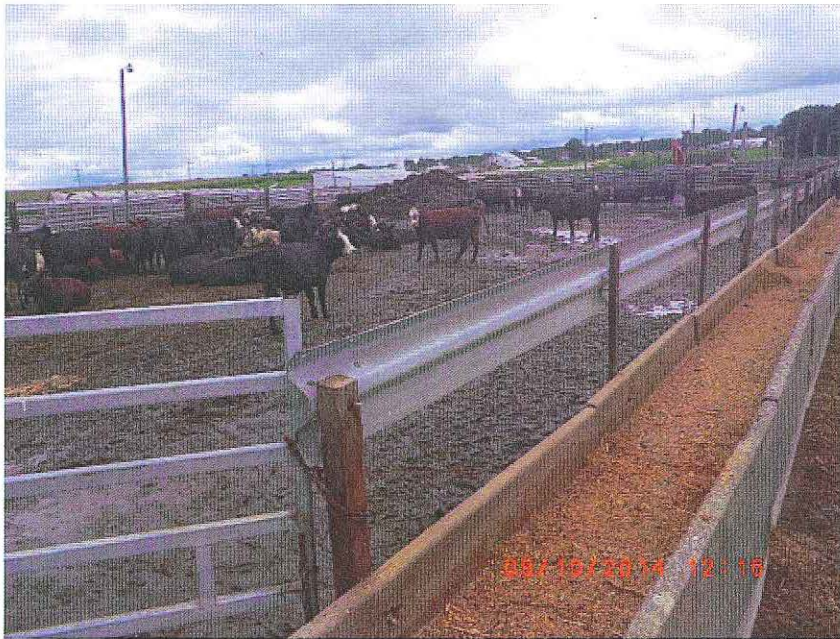
34: IMGP1396

Description: Cattle in Receiving Pen 14 and feed trough for the pen.

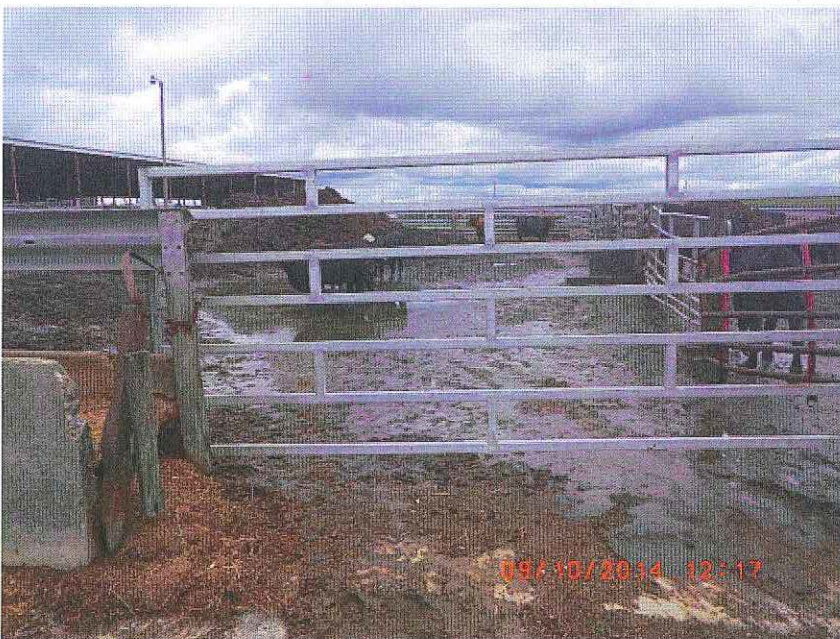
35: IMGP1397

Description: Runoff from Receiving Pen 14 flows to the southwest under the gate.

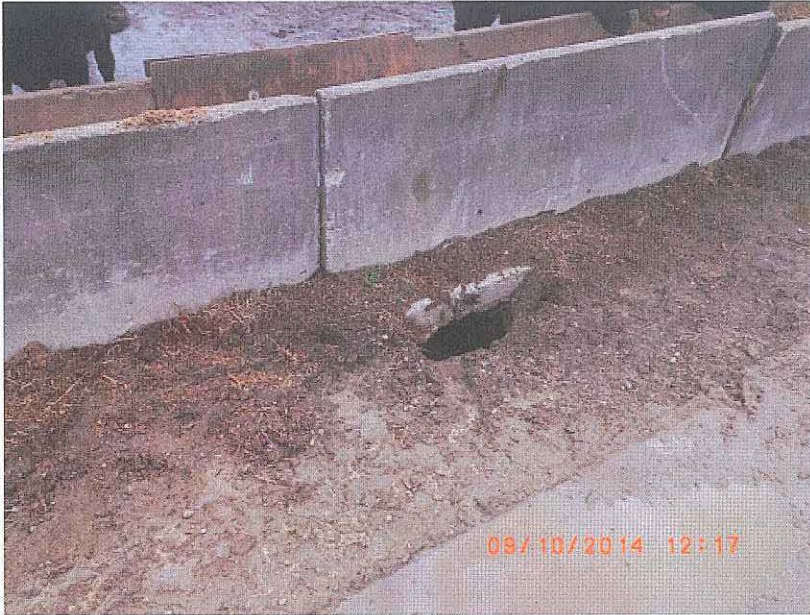
36: IMGP1398

Description: Flow from Receiving Pen 14 flows to an inlet outside the northwest corner of Receiving Pen 16.

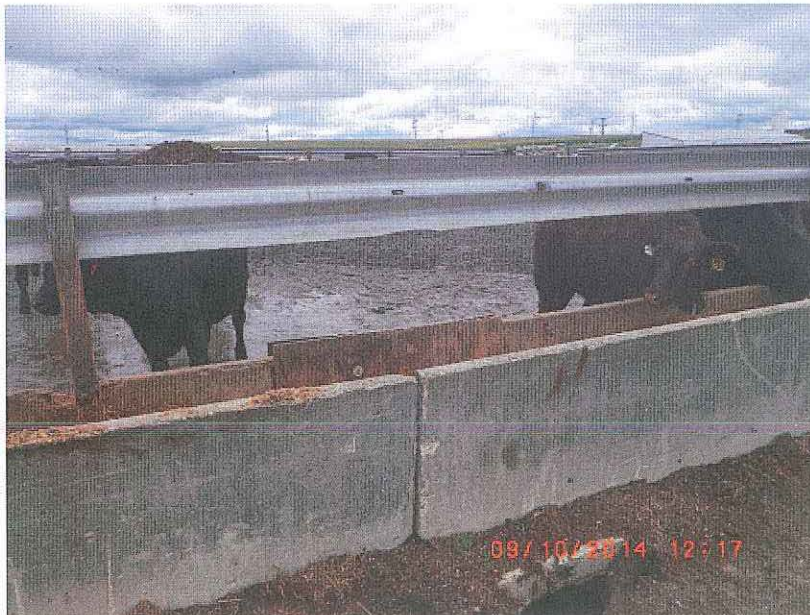
37: IMGP1399

Description: Inlet for the runoff from Receiving Pen 14 at ground level by Receiving Pen 16.

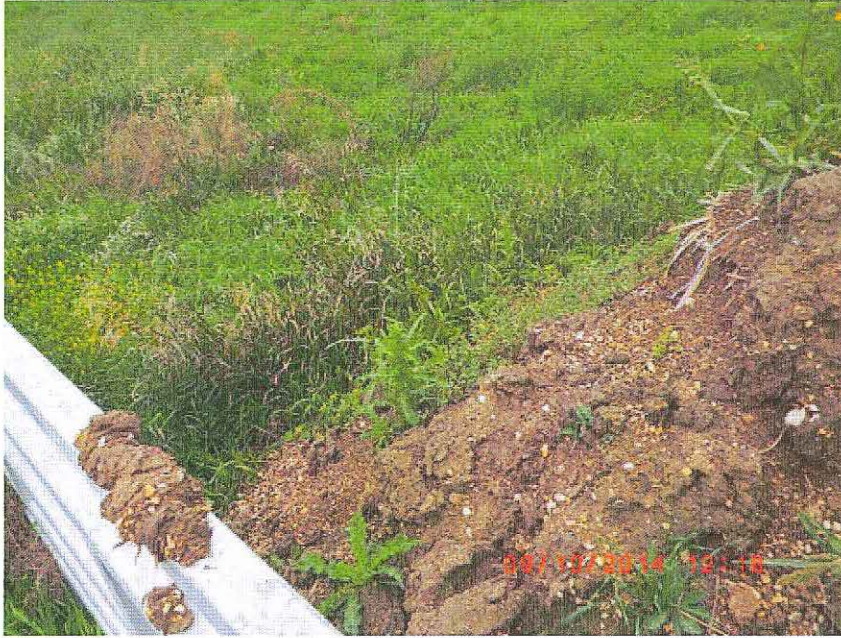
38: IMGP1400

Description: Pipe for flow from Receiving Pen 14 outlets in the hillside on the west side of the driveway. The hillside flows to the northern portion of the Lagoon. Outlet is under the vegetation.

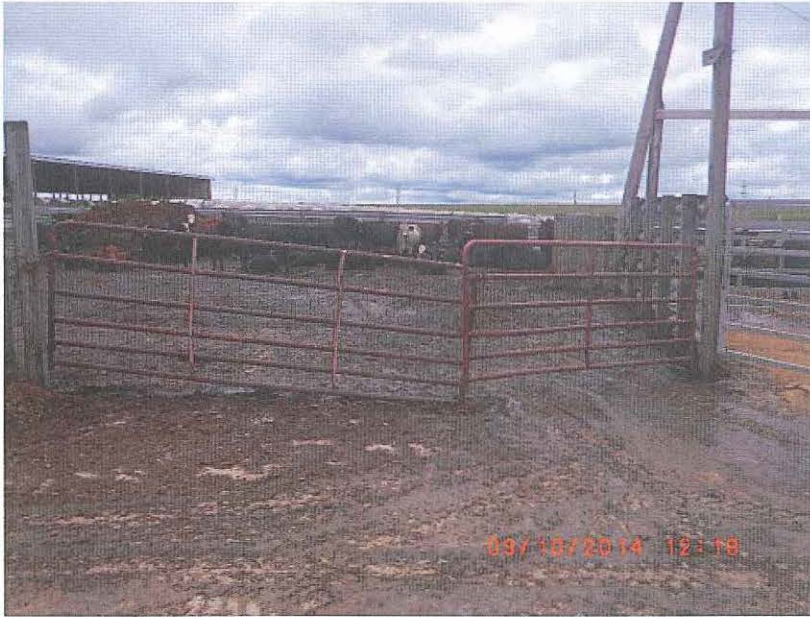
39: IMGP1401

Runoff of manure and process wastewater from Receiving Pen 16 flows to the southwest where some will flow into the Sort Alley. As described at the beginning of the walkthrough portion of this inspection report, manure and process wastewater from the Sort Alley flows to the south to a pipe inlet at ground level and from there to the Lagoon.

Description: Runoff from Receiving Pen 16 flows to the west and southwest under the gate.

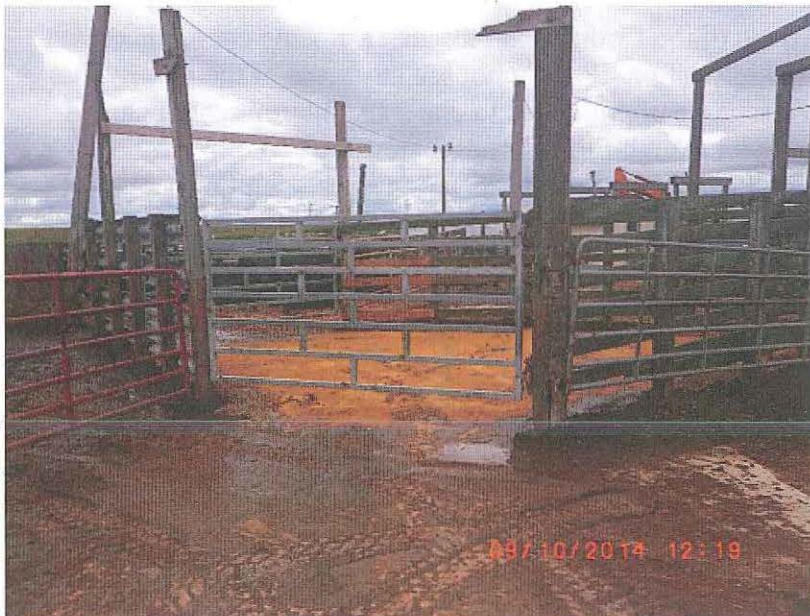
40: IMGP1402

Description: Some of the runoff from Receiving Pen 16 flows into the Sort Alley. Some will bypass the Sort Alley and flow to the south down the driveway.

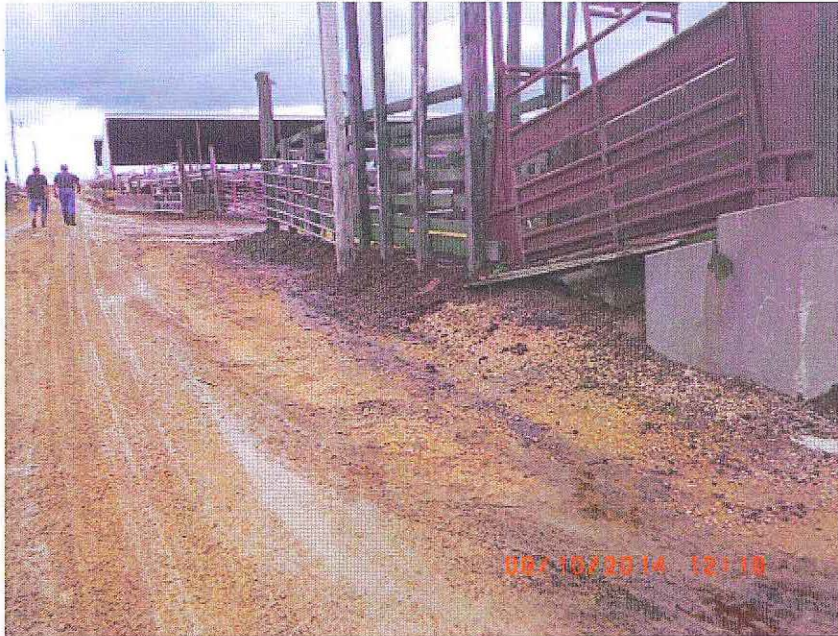
41: IMGP1403

The portion of manure and process wastewater that doesn't flow into the Sort Alley, flows to the south and down the hillside to the Lagoon.

Description: Runoff from Receiving Pen 16 flows down the driveway and would eventually flow to the Lagoon.
